DEMONSTRATION OF AN EXPLORATION TECHNIQUE INTEGRATING
EARTHSAT'S LANDSAT LINEAMENTS,
SOIL GAS ANOMALIES,
&
FRACTURE INTENSIFICATION DOMAINS
FOR THE DETERMINATION OF
SUBSURFACE STRUCTURE IN THE BASS ISLAND TREND,
NEW YORK STATE

FINAL REPORT

NYSERDA PROJECT # 4712

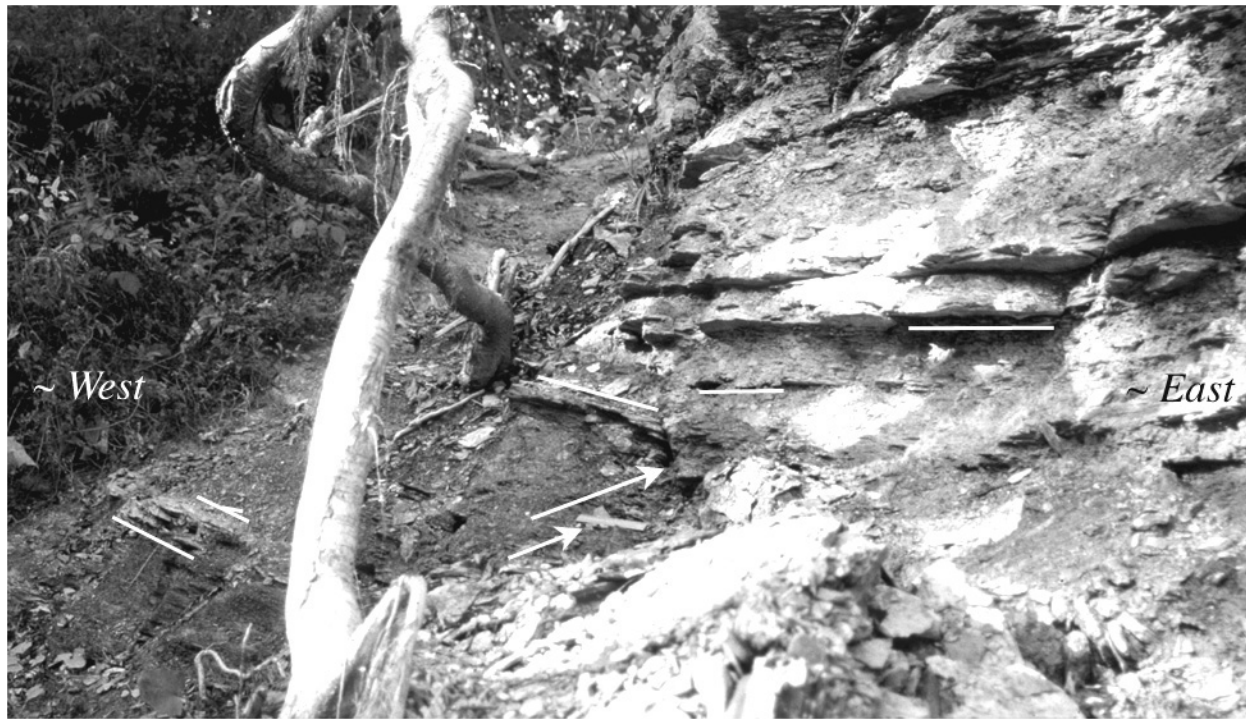
FIGURE 13

FIGURE 13. N-striking Faults in South Branch of Cattaraugus Creek. Map shows location of scanlines (red lines) and fractures measured along the scanlines. Modified rose diagrams portray the fracture orientation on the upper half and the relative length of fractures oriented in the direction of the petal in the lower half. Longest fractures are the master fractures. Note that the N-striking fractures of the FID have a curving-parallel (abutting) relationship with the NW-striking master fracture, indicating that the FID postdates the NW-striking Alleghanian fracture. From Jacobi and Baudo (1999). For location, see Figure 12.

Faults (Location Map, Figure 12). Faults observed in the region of Figure 12 strike primarily north and northeast. Generally, no evidence exists for faulting along the NW-striking FIDs. The N-striking faults in FID NS-3 (Figures 11C, 12, 13, 14) are particularly instructive. The faults occur where N-striking fracture frequencies increase by an order of magnitude near the faults (Figure 13). The trend of the N-striking faults appears to be displaced by the NW-striking fracture, but N-striking fractures associated with the faults have a curving-parallel abutting relationship with the NW-striking fracture. Thus, if the N-striking fractures were contemporaneous with the NS fault development, then the abutting relationship of the N-striking fractures indicates that the NW-striking fracture predates development of the N-striking fault. However, if the N-striking fractures postdate development of the fault, then the N-striking fault could be used as evidence that the NW-fracture experienced dextral strike-slip fault motion before the N-striking fractures developed. However, no decoration is observed on the NW-striking fracture surface that would support fault motion. Furthermore, the fracture ends at the gorge wall. Therefore, it is probable that the N-striking faults developed after the NW-striking fracture was generated.

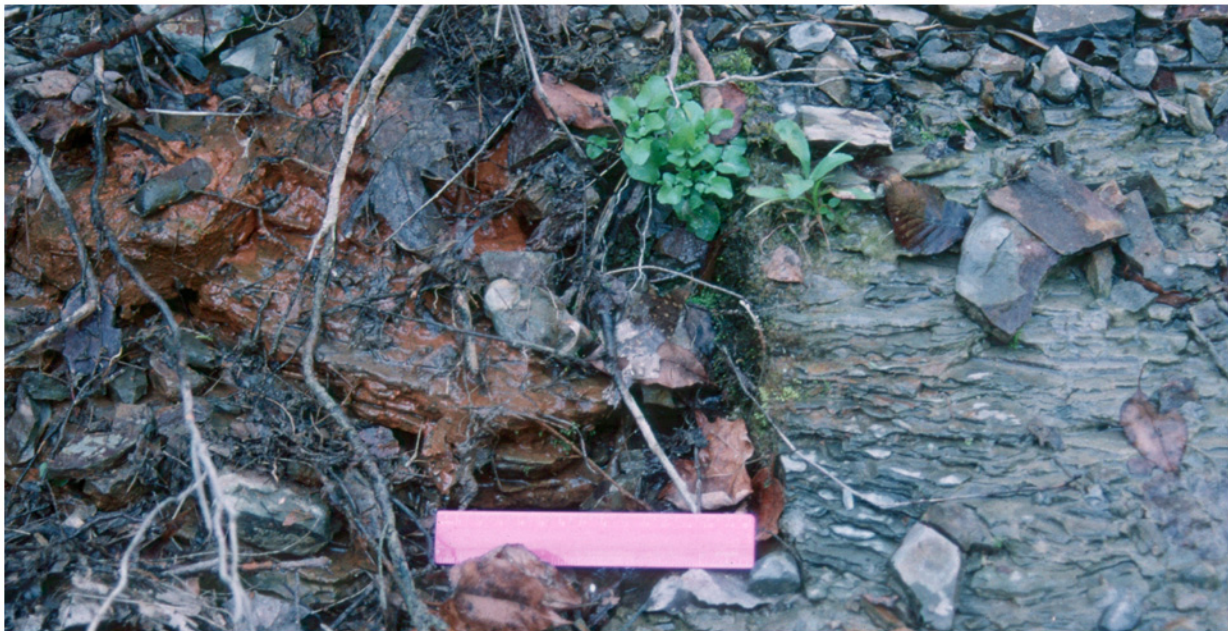
FIGURE 14A

FIGURE 14A. The North Fault in Figure 13. View is to the north. Note dipping units on the left in a horse caught up between the exposed fault (at long arrow in center of the photograph) and an assumed fault to the west. The units to the right of the fault are flat lying. Short arrow points to a 15 cm ruler. The white bars were added to the photograph to aid in distinguishing the dips.

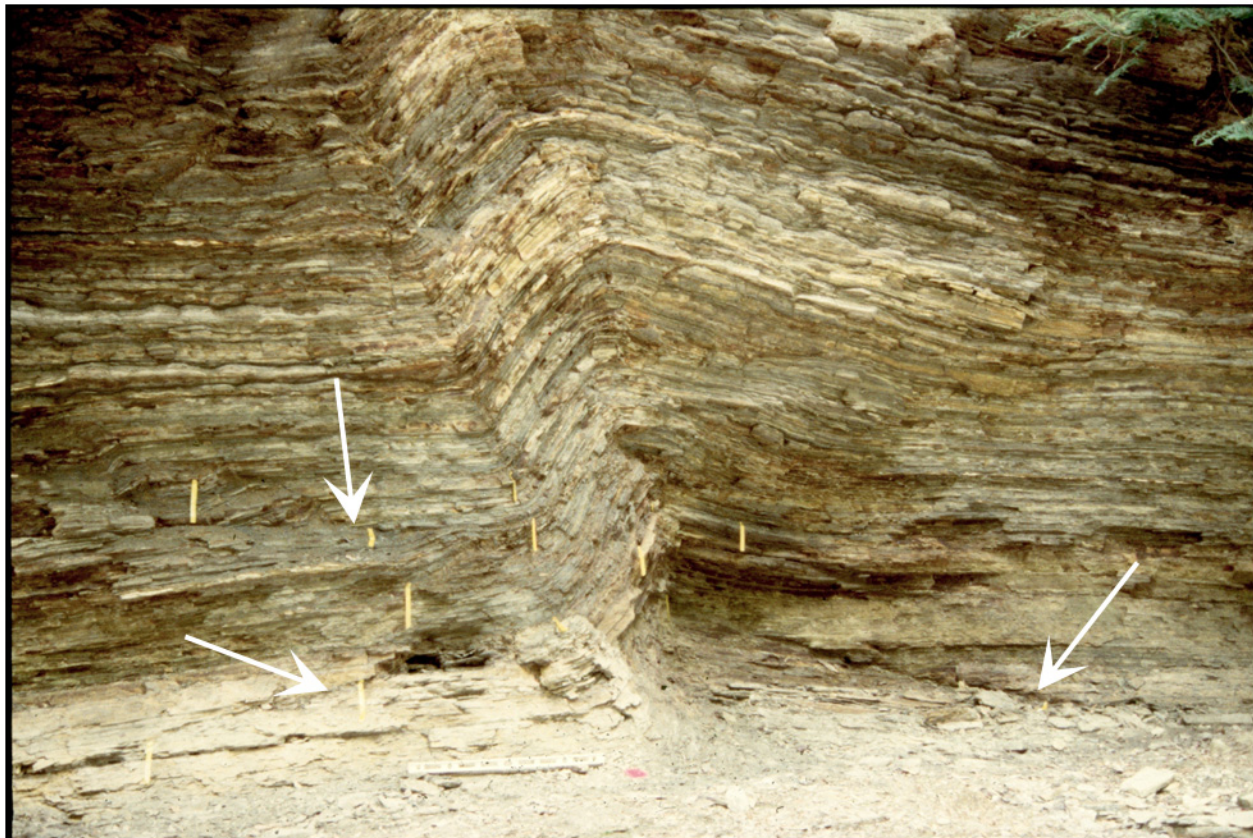
FIGURE 14C

FIGURE 14C. South Fault in Figure 13. View is to the north. To the left (west) of the fault, note the high dips of units at the arrows along the water edge. The units are flat lying east of the fault. Scanline tape for scale.
